⑥ National Dam Inspection Program.
Kelsey Creek Dam

KELSEY CREEK DAM

PHASE I INSPECTION REPORT

⑪
AUGUST 1979

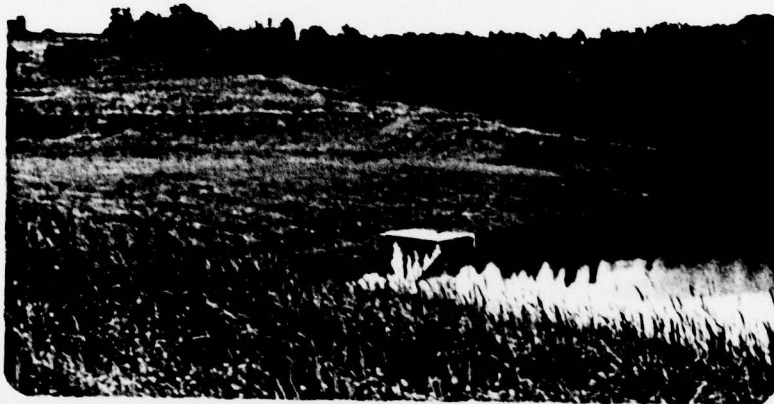
C. Main Spillway and Auxiliary
Spillway Approach Channel

The main spillway riser is in good condition. The conduit beneath the embankment could not be inspected because it was flowing about one half full. A minor amount of debris was at the orifice of the main spillway riser. The impact basin is in good condition. Very minor spalling, of no concern, was observed at a few localized areas of the concrete. Because of the high tailwater, it was impossible to determine if the drain

(1) Implement an inspection of the main spillway conduit and riser to determine if separation of the conduit joints and cavitation damage to the riser have occurred. If pool conditions prevent the

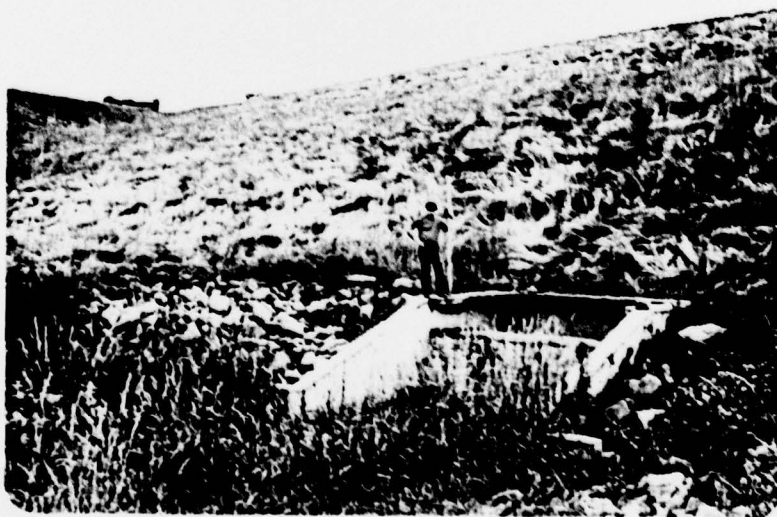
D. Impact Basin

pipes, which extend to the embankment toe drain, were discharging. The riprap downstream from the impact basin is in good condition. It appeared that someone had piled some of the riprap across the impact basin sill to create a pool at the impact basin.

(3) Appurtenant Structures. The gate for the outlet works is located sufficiently far upstream to be considered an upstream closure facility. The riprap at the endsill of the impact basin raises tailwater slightly. This is not a hazard to the dam, but it does hinder visual inspection. The crest elevation of the auxiliary spillway indicates that the spillway capacity is slightly greater than the design computations indicate.

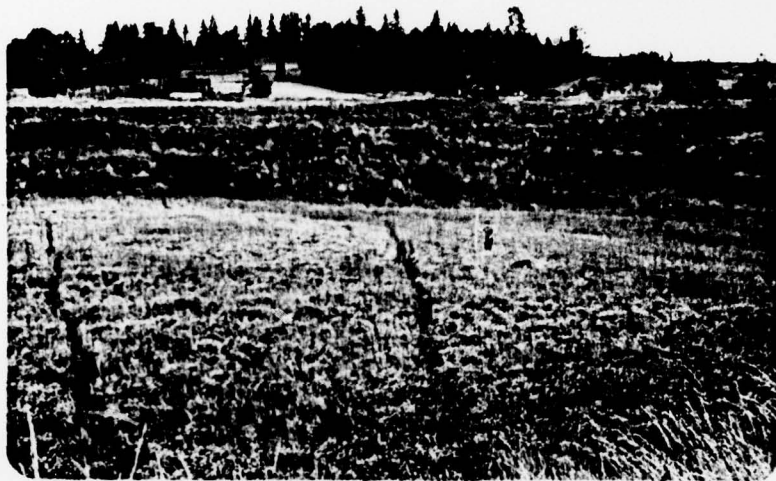
E. Auxiliary Spillway Crest

The auxiliary spillway is in good condition, The grass cover is in good condition; it is at least 3 feet high. The survey performed for this inspection revealed that the control section invert is between 0.6 foot below to 0.5 foot above the design elevation. Because of the tall grass cover, it is uncertain that the measurements were made along the crest of the control section. This may explain part of the difference between the actual and design elevation.
